Nondestructive Large Area Testing using Shearography

General

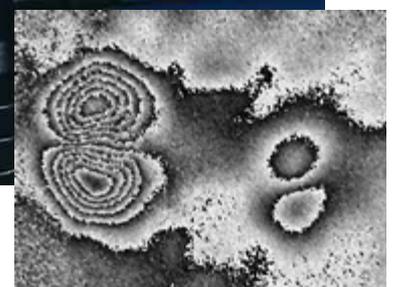
Fig. 1: Phasemap of two impact damages.

Fig. 2 shows the schematic of a shearography equipment. A laser beam illuminates the test object and a shearing sensor, with optics and a CCD-camera, registers the reflected light. The optics in the shearing sensor will double and laterally shear the image of the object producing a resulting image called a speckle interferogram, which is a unique space map of the surface. A speckle interferogram can only be made when coherent, divergent light is reflected on a diffuse surface. By comparing interferograms before and after loading a fringe pattern is produced, as can be seen in Fig. 1.

Shearography is an optical method that gives information about surface deformation of a loaded structure. The load can be induced by heat, vacuum, pressure, sound or vibration. The surface area above a defect will deform differently than the surrounding surface area, which will be recorded with shearography, and presented as typical patterns (see Fig.1). Surface deformations of a few microns can be observed.
